THE OLD-HOUSE JOURNAL

Restoration And Maintenance Techniques For The Antique House

Vol. VII No. 8
August 1979

Restoring A Colonial Roof

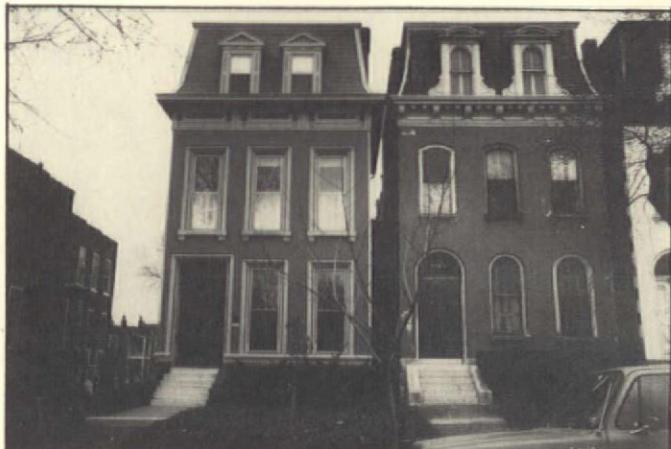
This photo shows the Keay home after completion of the third storey addition.

HAVING MADE UP THEIR MINDS to replace their third floor after a nearly 80-year absence, the Keays sought the help of the Renaissance Design Group, a partnership of young architects and carpenters who lived in the neighborhood, which specialized in restoration work. Together the Keays and RDG decided to build a mansard shell, rather than following the original design which extended the structure's masonry walls upward another storey.

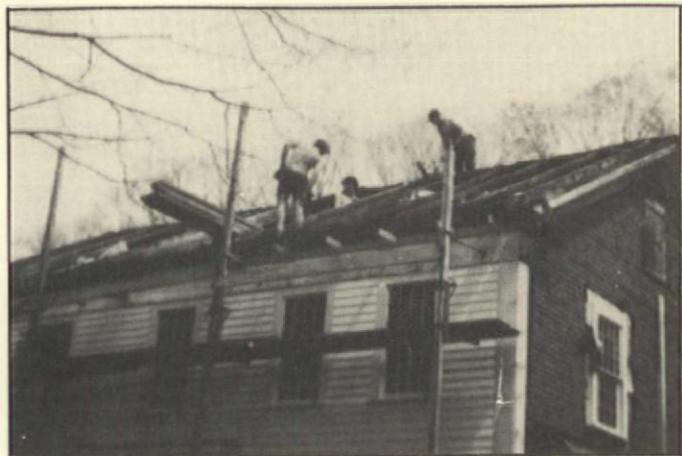
During the roof restoration the original hand-hewn rafters were reinforced.

OUR NEXT STEP was to reinforce the roof rafters. The original rafters were hand hewn from hemlock timbers, so we decided they should be saved for their aesthetic and historical value. These original rafters were reinforced, but not replaced, with new timbers running parallel to them. The building's antique framework thus stayed intact.

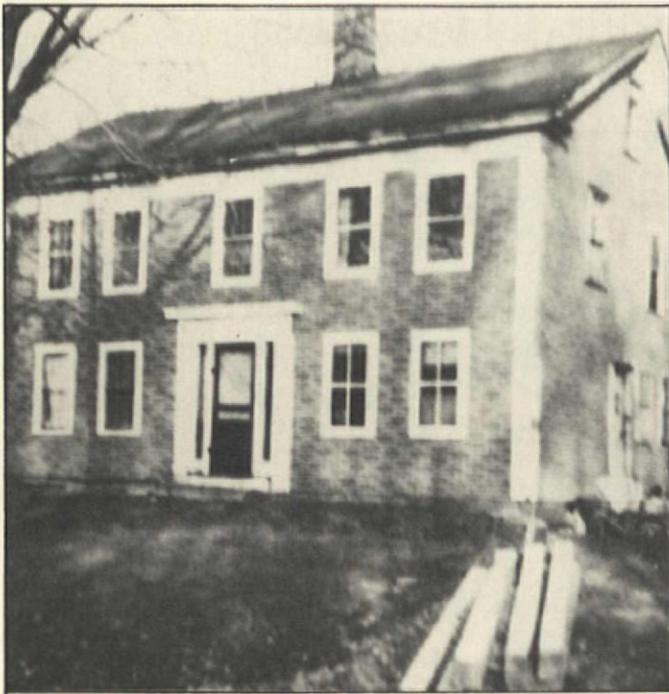
This is a snapshot of the Freeman house before roof restoration began.

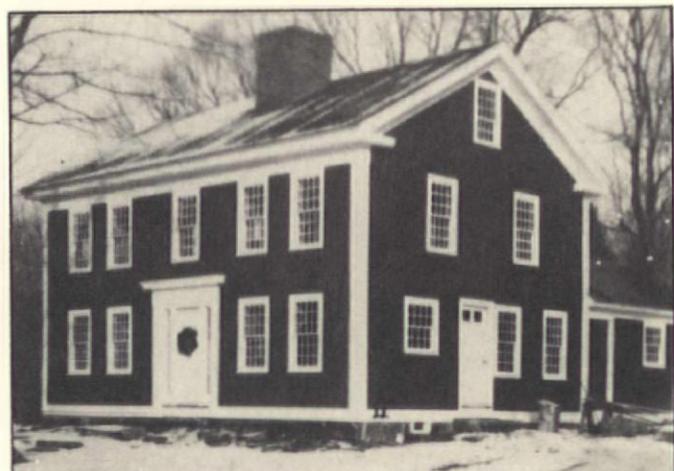
After restoration--the clapboards are now painted brick red as they were originally.

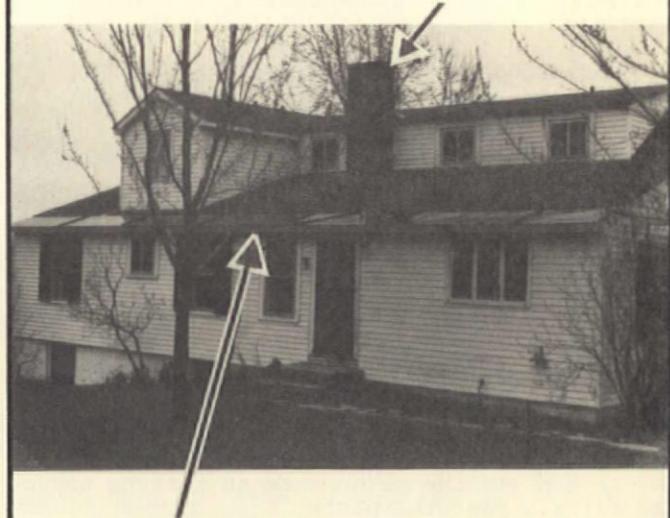
Leak still showed up (arrow) after a new roof had been put on and a galvanized metal ice edge had been installed at the eaves.

THE NEW ROOF AND ICE EDGE was completed in the early fall. About the second week in December, a few days after the first heavy snowfall, the owner called me and said that the leak had reappeared, in the SAME PLACE!!! Needless to say, I found this hard to believe. I have made numerous similar installations, and they have all proved satisfactory. I went right over to take a look.

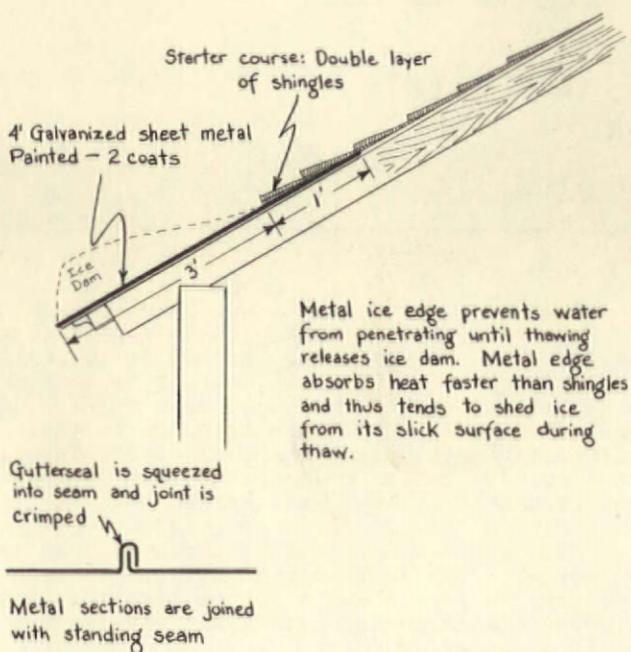
METAL ICE EDGE PREVENTS LEAKAGE FROM ICE DAMS

be used.) The metal is firmly bedded in roofing cement and then joined in sections with a crimped standing seam (see diagram). They can be joined in full-length 8-ft. sections, but I prefer to cut the sheets in half to make seams every 4 ft. These shorter sections have two advantages: (1) I find them aesthetically more pleasing; (2) Having more joints gives greater allowance for expansion and contraction.

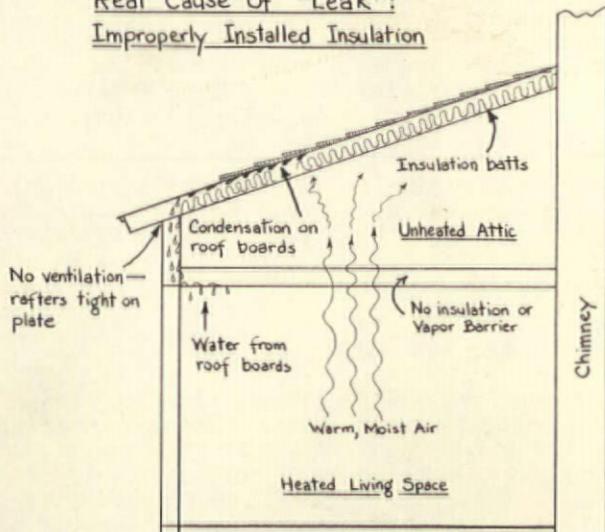
Real Cause Of "Leak": Improperly Installed Insulation

Real cause of the "leak": Warm, moist air was rising into the cold attic from the living spaces. Moist air was getting behind the insulation batts and condensing against the cold roof boards; condensed water then leaked down into the ceiling.

HIS TALE HAS TWO MORALS: (1) When setting out to fix a leak in a roof, be SURE you know where the water is coming from; (2) Beware installing insulation between roof rafters. If it is imperative to put insulation in the top of an attic, be sure there is provision for ventilation BEHIND the insulation. See OHJ, Sept. 1976, p. 9, for a general discussion of attic insulation problems.

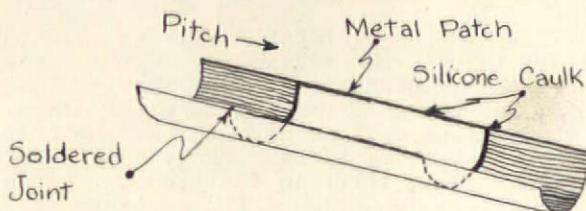
Metal Patch Allows For Expansion

PATCHES CAN BE MADE WITH METAL—but be sure to use the same metal as the gutter is made from. This will avoid corrosion by galvanic action

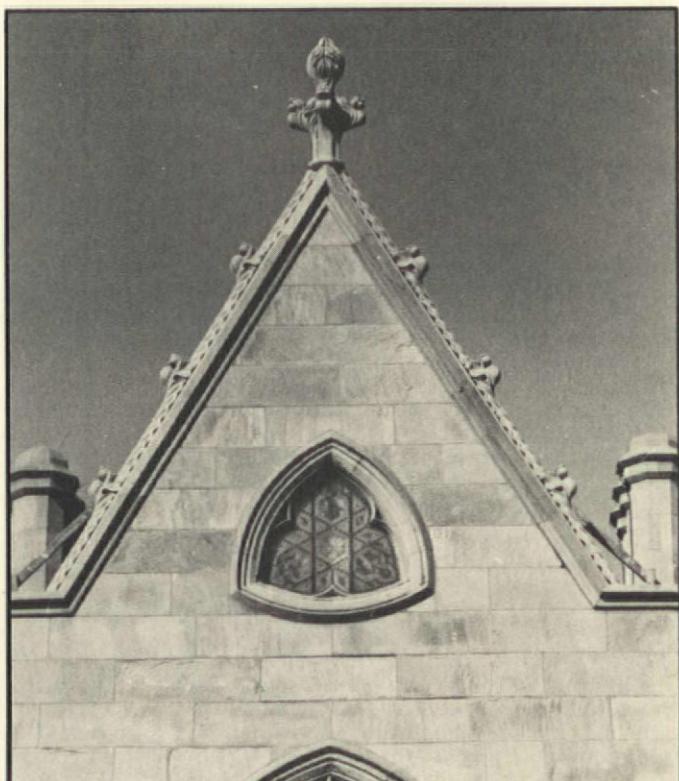
East gable of Lyndhurst, the Gothic Revival mansion in Tarrytown, N.Y., has its wooden finial, crockets and mouldings sand painted to resemble stone. (Photo courtesy of The National Trust for Historic Preservation.)
